Appendix 5-A Existing Structures

EXISTING STRUCTURES

Table 5A-1 Existing Structures
Construction Dates

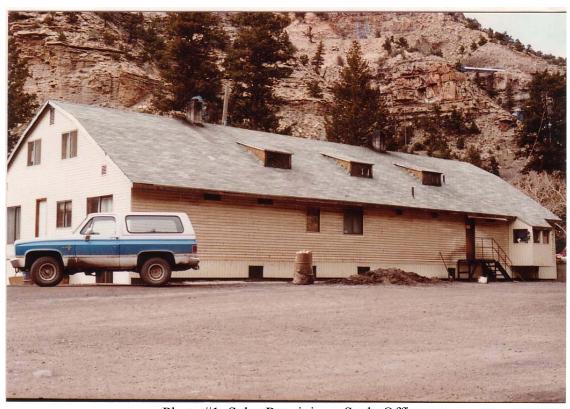
Photo #1 Sales Receiving - Scale Office

- 1. <u>Sales/Receiving/Scales Office/Caretaker Dwelling</u>. This structure contains the parts warehouse, parts receiving, scale office, mine offices, and the Caretaker Dwelling. See Photo #1.
- 2. <u>Fuel Tanks</u>. There are three 10,000 gal. fuel storage tanks installed at the downslope of the shop area. These tanks are contained within a natural berm of

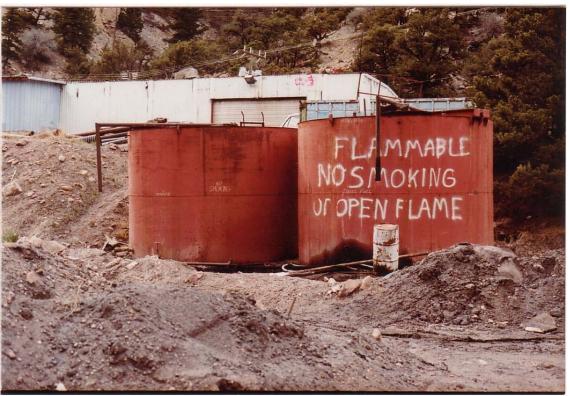
Photo #2 Fuel Tanks

the slope with the only access by way of the disturbed drainage ditch leading directly to the sediment pond. The pond is designed to contain any spillage which could foreseeably occur. The area will be posted "No Smoking" and fire extinguishers are in place. All MSHA safety standards will be adhered to. See Photo #2.

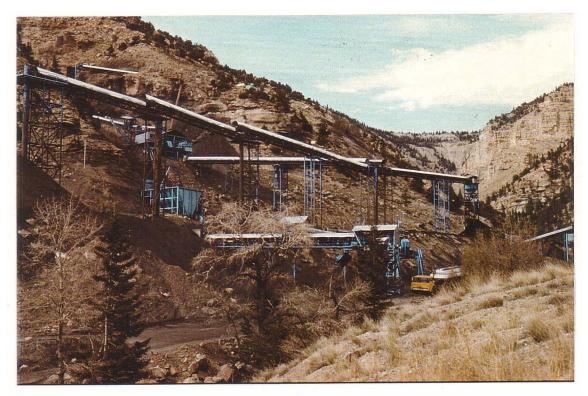
Photo #3 Truck Loading Facility, Oil Slack Loading Facility, Storage & Stacking Facility

- 3. <u>Truck Loading Facility</u>. The truck loadout is a conveyor system designed to load tractor-trailer trucks from any of the storage pile areas. It is electrically manipulated so as to minimize spillage. The area is cleaned of spilled coal as needed. All runoff is routed to the Sediment Pond "A". See Photo #3.

- 4. Oil/Dry Slack Loading Facility. The slack loadout is designed to handle oiled and non-oiled stoker coal, primarily for non-commercial clients. It includes a 20,000 ton storage bin with an electrically operated auger to load small tonnages. The bin is fed by a hopper and conveyor, which is loaded with a front end loader. See photo #3.

- 5. <u>Coal Storage Area and Stacking Facility</u>. The coal storage yard is equipped with a system of conveyors wherein coal can be segregated according to size. This storage is of a short-term nature; the piles are constantly being consumed and replenished. The area also contains two 6,000 gal oil storage tanks, which are used to store oil for stoker coal. All run-off is controlled, and passes through the Sediment Pond "A". See Photo #3.

- 6. <u>Conveyor Structures</u>. These conveyors are the route by which the coal exits the mine to the storage piles and loadouts. See Photo #3.
- 7. <u>Shop/Machine Shop</u>. The shop building is for servicing of both underground and surface equipment. The building is heated with a coal furnace and is equipped with standard heavy equipment handling implements such as winches, welders, etc. See Photo #4. A new machine shop (30 ft by 40 ft) was added in 1989 to better facilitate mine related repairs. See Photo #5.

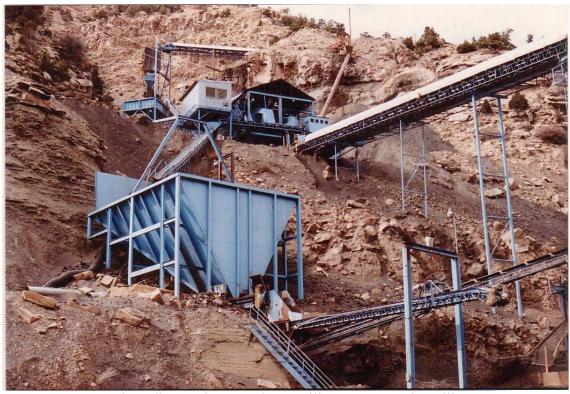
Photo #6 Coal Processing Facility, Lump Coal Facility

- 8. <u>Coal Processing Facility</u>. This facility is primarily a coal sizing site where the various sizes of coal can be made and then stacked in the designed locations. Runoff from this area is routed to the Sediment Pond "A". See Photo #6.

- 9. <u>Lump Coal Facility</u>. This structure consists of a storage bin and loading conveyor. See Photo #6.
- 10. <u>Non-Coal Storage Yard</u>. This area is utilized for all material which is in storage on the property with projected use and/or salvage value. Runoff from this area is routed to the Sediment Pond "A". See Photo #7.

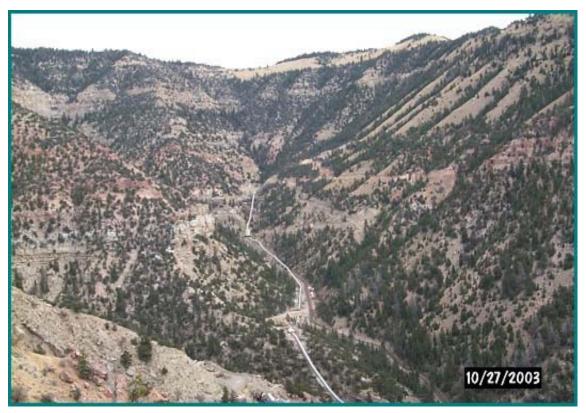
Photo #9 Cross Wild Horse Ridge Conveyor Belt

<u>Cross Conveyor</u>. This belt conveys the coal from the Blind Canyon Seam to the coal storage bin. See Photo #9.12.

Fan came from the old Tank Seam mine and is MSHA approved, and all safety guards are maintained in place. See photo #19.
- <u>Wild Horse Ridge Conveyor Belt</u>. This structure transports coal from the Bear Canyon No. 3 Mine to the tipple facilities.

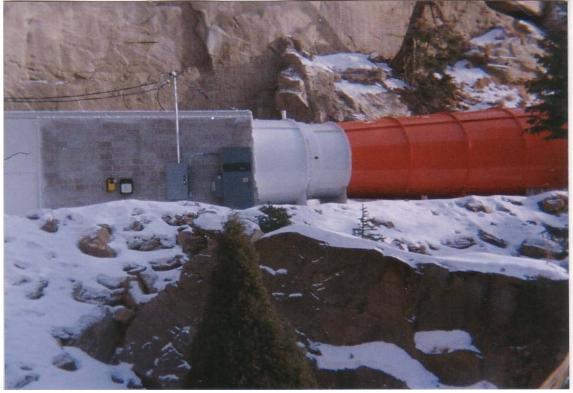
Photo #10 WHR Tank Seam Fan

- 1213. WHR Tank Seam Fan. The Wild Horse Ridge Tank Seam Fan (Shown in Photo #10) was the old Blind Canyon Fan and is MSHA approved. All safety guards are maintained and in place.
- 1314. Coal Storage Bin. This structure consists of a 20 ft X 20 ft surge bin to receive

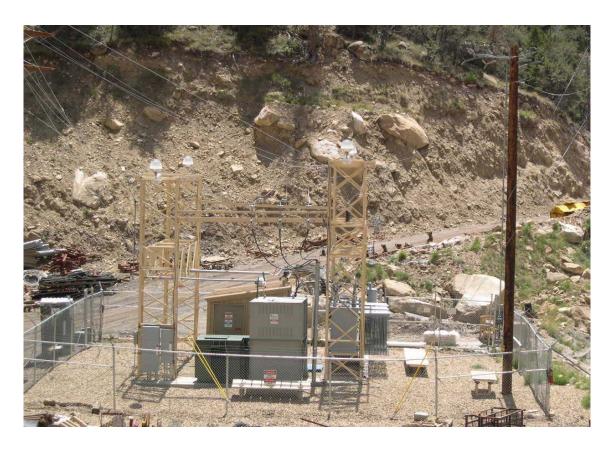
Photo #12 WHR Substation

- <u>WHR Substation</u>. This facility supplies electrical power to the surface and underground facilities operating in Wild Horse Ridge.
- 25. WHR Retaining Wall. The wall is 30 feet tall and 300 feet long and was installed to allow for the widening of the upper Tank Seam access road.

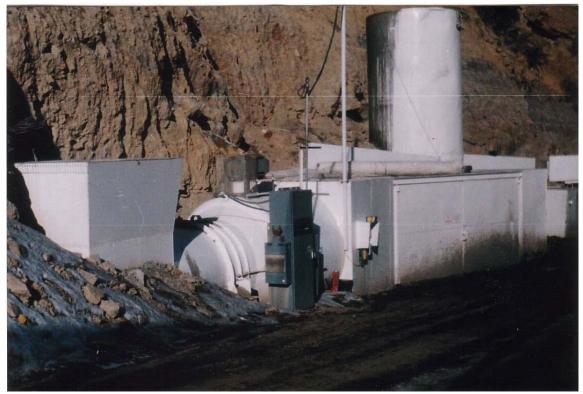
Photo #19 WHR Blind Canyon Seam Fan

- WHR Blind Canyon Seam Fan. The WHR Blind Canyon Seam Ventilation
